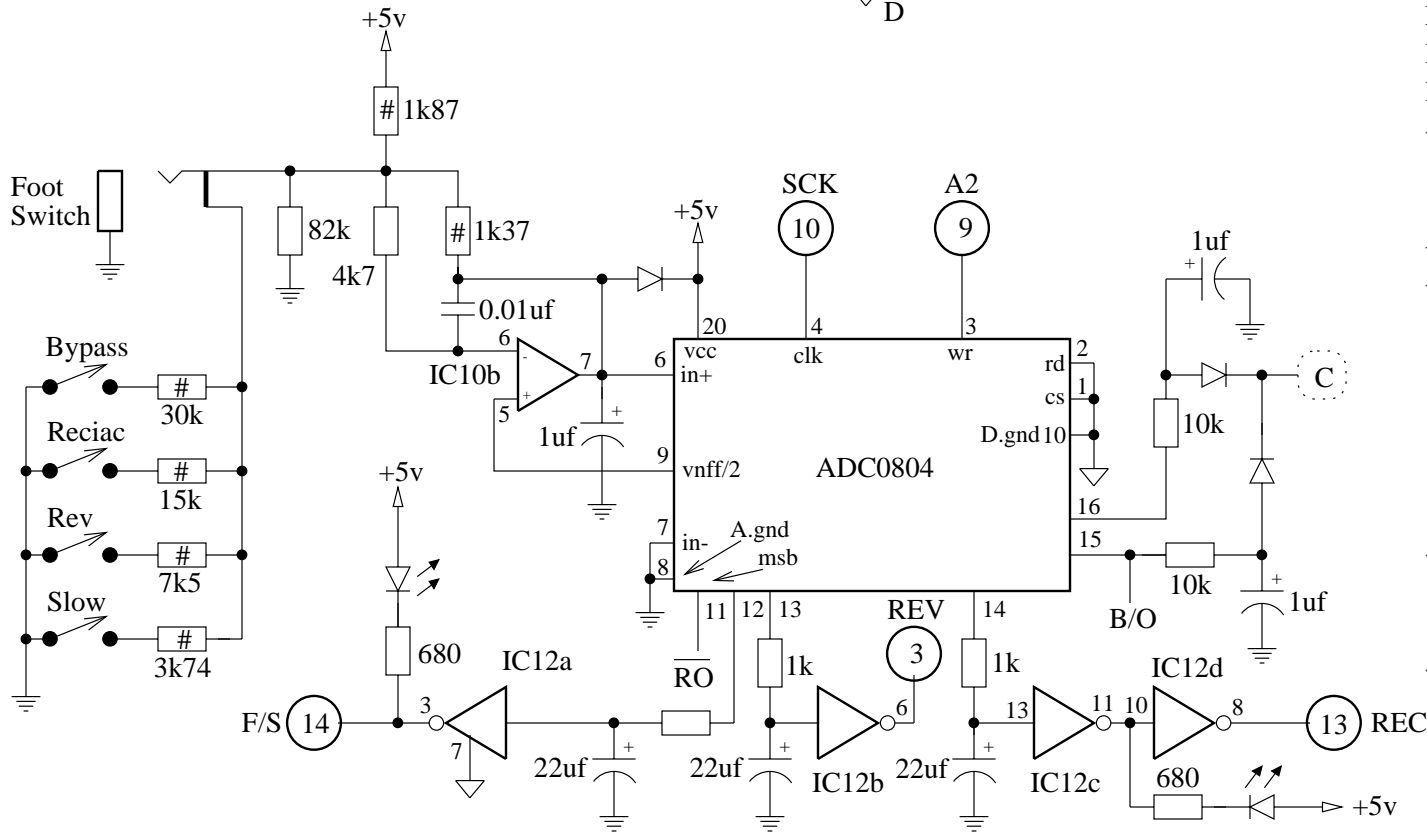
| IC1 - TL082 | IC9 - 571 | IC7, IC8 - Unmarked ? |
| IC2 - 4558 | IC11, IC4 - Unmarked Dual Op-Amp, probably a 4558 | |
| Q1, Q4 - 2N5087 | D1, D2 - Signal Diode ? | |
| Q2, Q3 - 2N4859A | D3, D4 - 6.8v Zener | |

Resistors marked # are 1% types.
 IC10 - LM358
 IC12 - unmarked, CD4049 perhaps?
 +12v to pin 8 on IC1, IC2, IC4, IC5, IC6, IC10, IC11, IC43, & IC44 pin 13 on IC9, & IC3
 +10v to pin 5 on IC7, & IC8
 +5v to pin 20 on the ADC0804 a pin # I couldn't read on IC12 pin 14 on IC13, IC14, & IC21 through IC24 pin 16 on IC15 through IC18 pin 3 on IC19 pin 8 on IC20, & IC30 through IC41 pin 20 on IC27, & IC42 pin 5 on IC28 pin 12 on IC29, & IC3 pin 7 on IC44 pin 9 on IC19
 -15v to pin 4 on IC1 through IC4, IC10, IC11, IC20, IC43, & IC44 pin 17 on IC42
 -10v to pins 1 & 6 on IC7, & IC8

All diodes were unmarked.
